# TECHNICAL BULLETIN

**Technical Bulletin Nr. 006-14**  
February 12th, 2014

| <b>Product:</b> | Gantry Davits Electric Travelling for life rafts type GDET-RF35P |
| <b>Purpose:</b> | Maintaining the efficiency of the end shaft on travelling reduction gear |

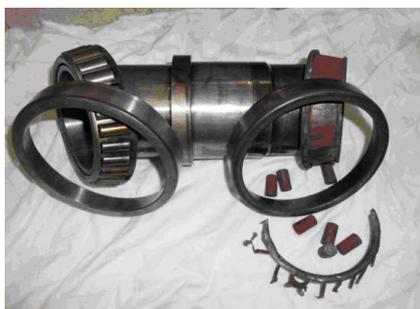
- 1. Presence of rust and evident traces of corrosion into the gear box and free end of the transmission shaft, with the consequent breakage of the ball bearing.**

the corrosion of the bearing started due to damaged sealing.

1. Increase the oil level inside the gear box in way to put under corrosion protection the shaft bearings in due of the manual operation of the system. Increasing the oil level there created an internal protection of the ball bearing , but it is necessary to pay more attention for leakages from the lip seal at the end of the shaft.
2. Protection with grease of the shaft end and lip seal. This is part of routine maintenance as indicated in OMM.
3. Reduce the exposition of the gear box end shaft by providing a protective cover. This is an improvement that have low a cost impact but will enhance the safety integrity level of the system. It requires the installation of part number 72/1/10-19-20.

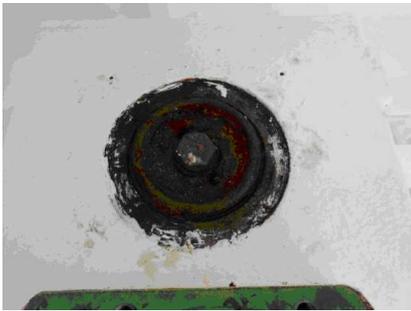
- 2. Inadequate, and in some cases lack of a sufficient maintenance and protection of the free end shaft of gear box.**

The external position of the shaft, its exposed position, and lack of maintenance have resulted in the presence of rust that damaging and accelerate the aging of lip seal. (1)

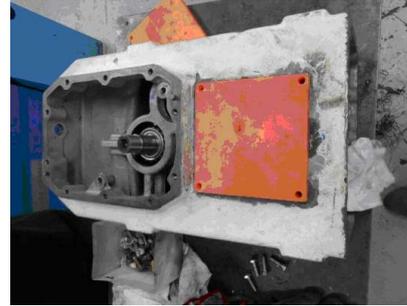
(2)

**3. Lack of a sufficient level of oil inside the mechanical gearbox casing or not sufficient rotation speed with result of lack shaking lubrication . (2)**

The bearings and the mechanical parts inside the gearbox casing were not properly lubricated and showed the beginning of rust due to lack shaking lubrication, since the gearbox is more frequently manually used than by electrical power.
