Technical Bulletin Nr. 001-025

Applies to: Telescopic davits on Mitsui Ocean Fuji (Mariotti hull n.062) - Seabourn Sojourn (Mariotti hull n.063) - Seabourn Quest (Mariotti hull n.064)

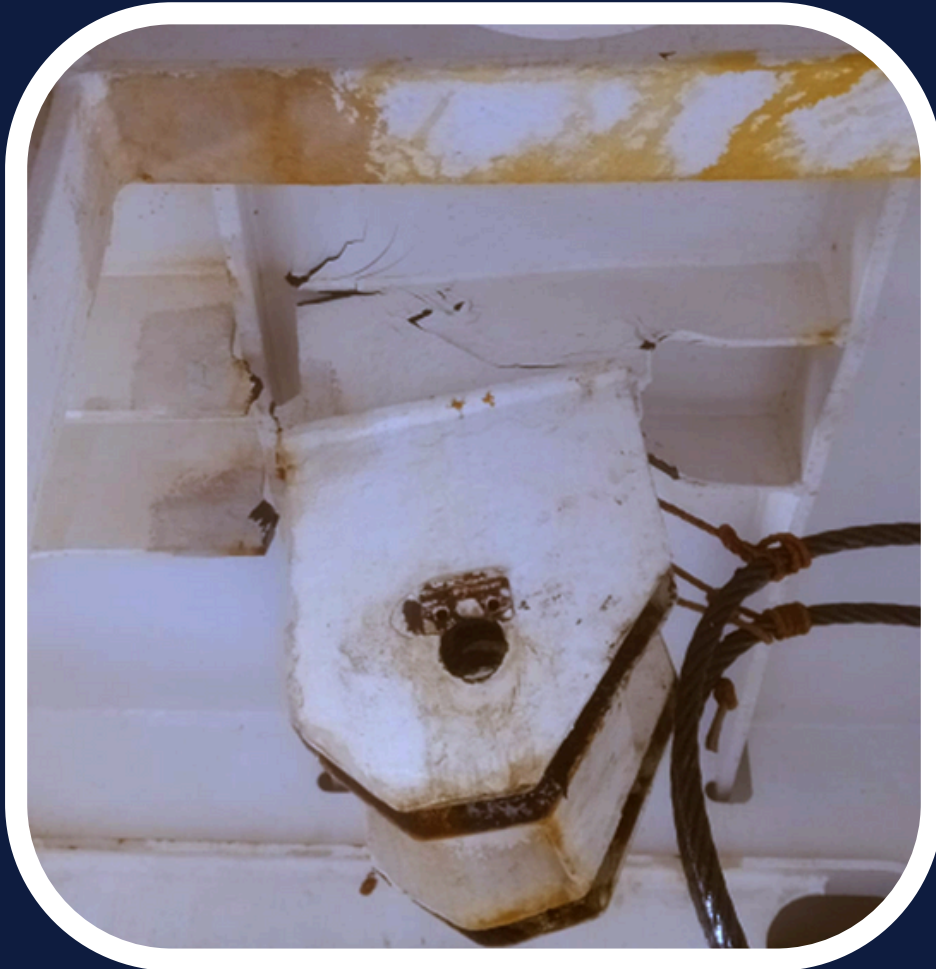
During the overload tests on MV Seabourn Sojourn (Mariotti hull n.063), a failure of steel plates connecting pulley boxes to the hull has occurred, which was caused by the partial corrosion of the plates.

Photo 1 - Failure of the plates connecting the pulley boxes to the upper deck

The said connections have been designed in accordance to SOLAS, have been approved by the Classification society, and have been in service for 17 years before the failure under the overload.

In accordance with the Class Surveyor, a repair has been performed on board, which has restored and improved the structural integrity of the hull connections, thus ensuring a higher corrosion tolerance for the rest of the vessel's service life.

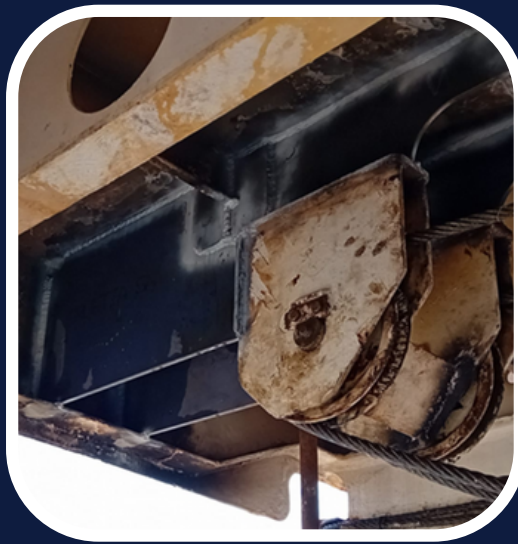
Photo 2 -New connecting plates for the pulley boxes
