Product	LOWER BLOCKS WITH ROTATING SWIVEL AND FIXING NUT Types : all Navalimpianti davits
Purpose	Maintaining the efficiency and reliability of the hoisting system
Summary	Inspection and maintenance to the swivel nut

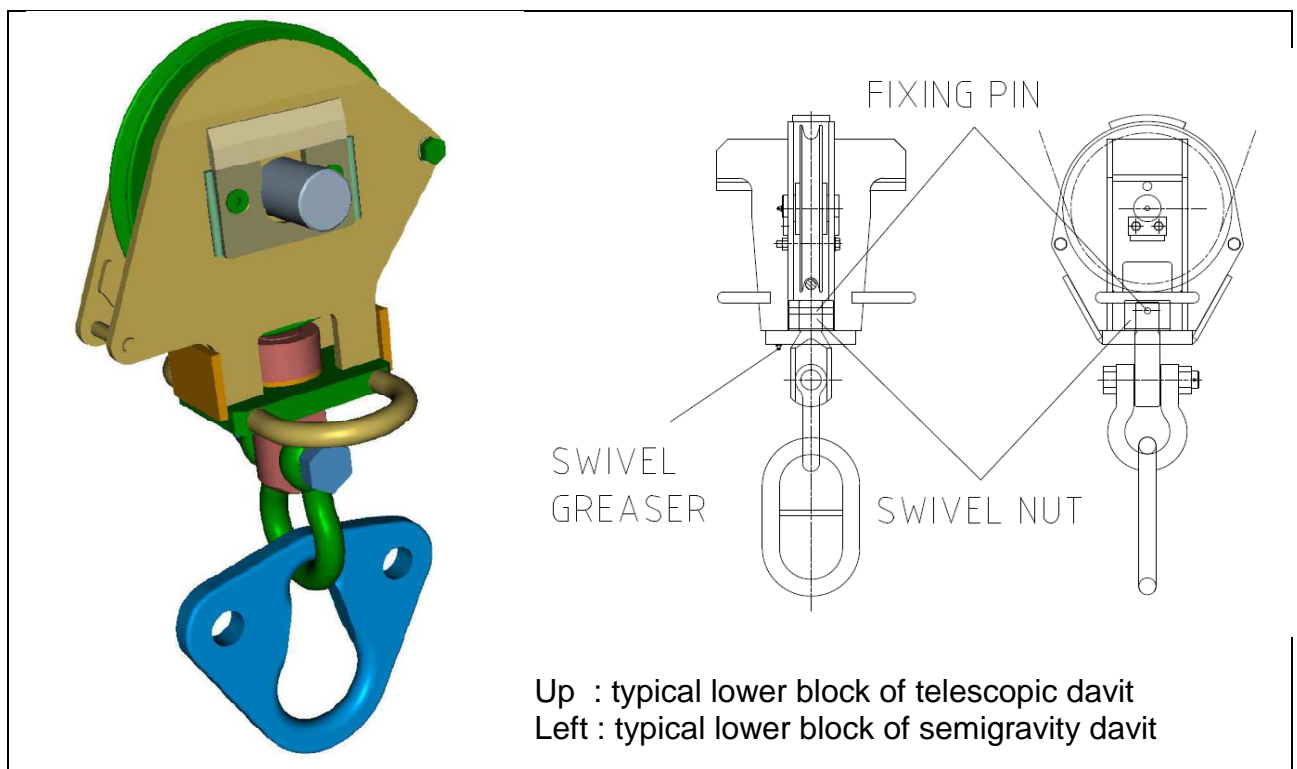
The fixing nut is made in galvanized steel [1] and fastened to the swivel by a pin (originally in copper, then in elastic steel [2]) as safety unscrewing device.

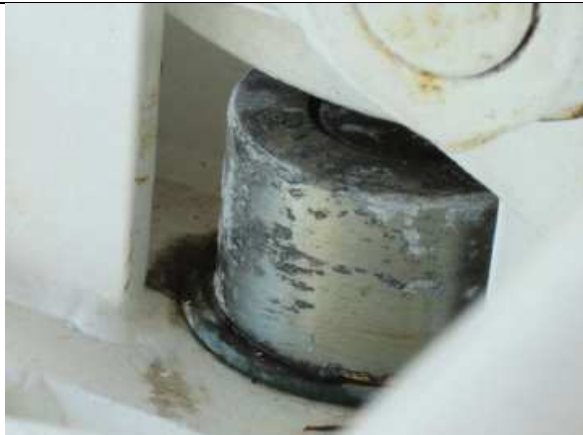
Recently we received an information that, due to the similarity to the steel galvanization with the stainless steel axle (AISI 431) of the pulley, someone could be inducted to believe that should not necessary to maintain and paint the fixing nut (see pictures).

1 - Starting corrosion in the first service year

- to inspect these nuts, brushing and re-painting it in case of rust;
- pay attention to seal the upper surface to avoid salt water penetrates between the nut and the swivel bolt end,
- grease accurately the bronze washer to be sure the swivel rotates with less friction,

- unscrew the nut inspecting the thread integrity, brush and protect,
- change the fixing pin, fill and seal both ends with neutral silicon,
- check the wearing status of the bronze washer and grease it,
- check the greaser efficiency and the greasing channel is free,
- brush and repaint accurately the whole nut surface,
- do not forget to make the same maintenance to the swivel too.

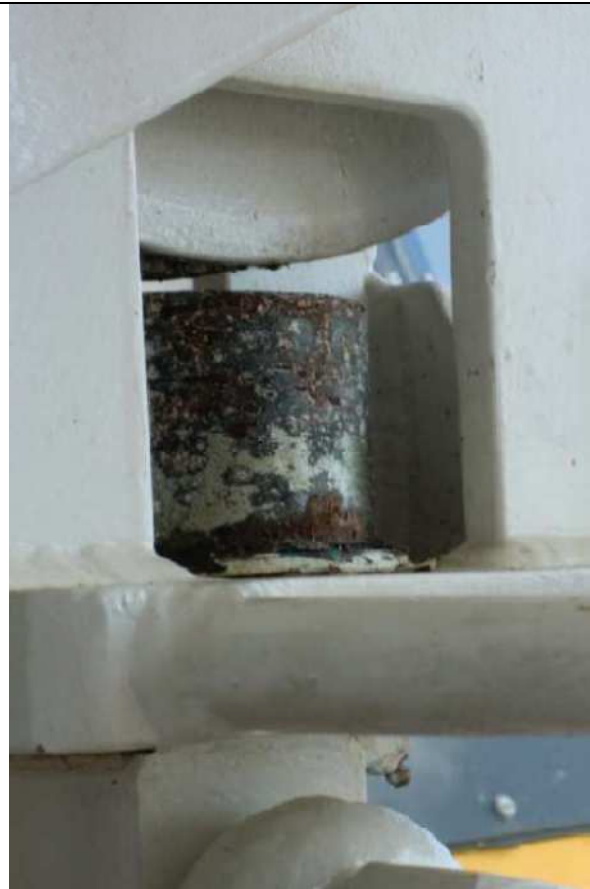
2 - Intermediate corrosion status

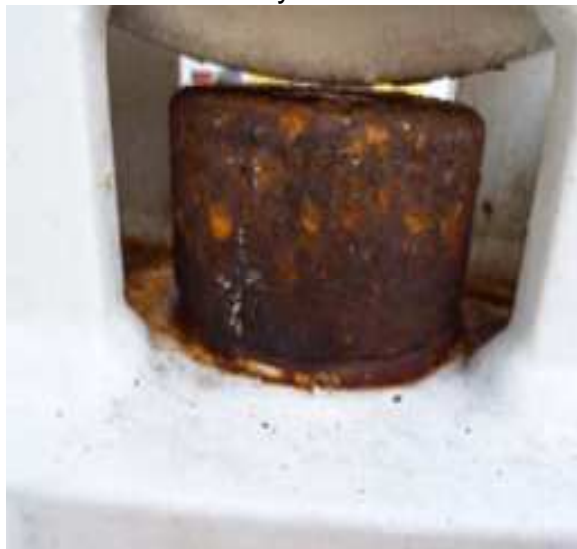
3 - Severe corrosion after about two years without maintenance

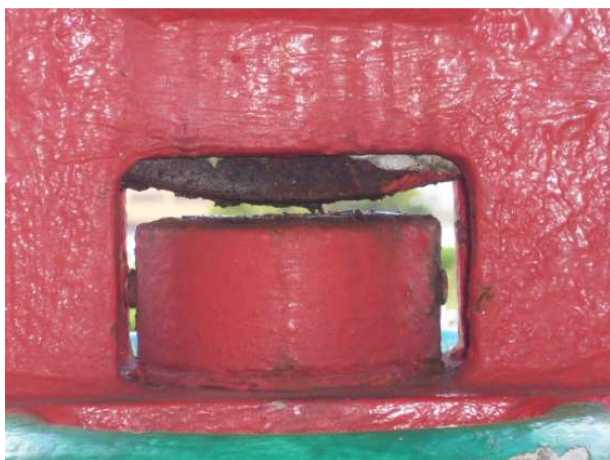
4 - Painted swivel nut well maintained after more than five service years.

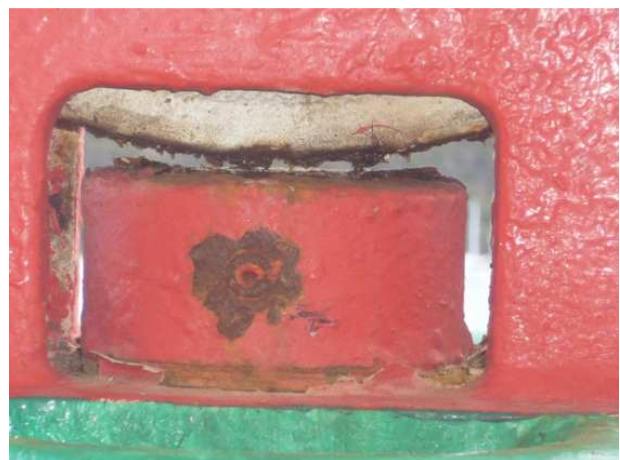
5 - Another swivel nut of the same vessel. The corrosion starts from the elastic pin.
